Inspection Report
Central Plant Cooling Tower

Prepared By:
OBR Cooling Towers, Inc.
912 Mill St.
Toledo, Ohio 43609
419-243-3443

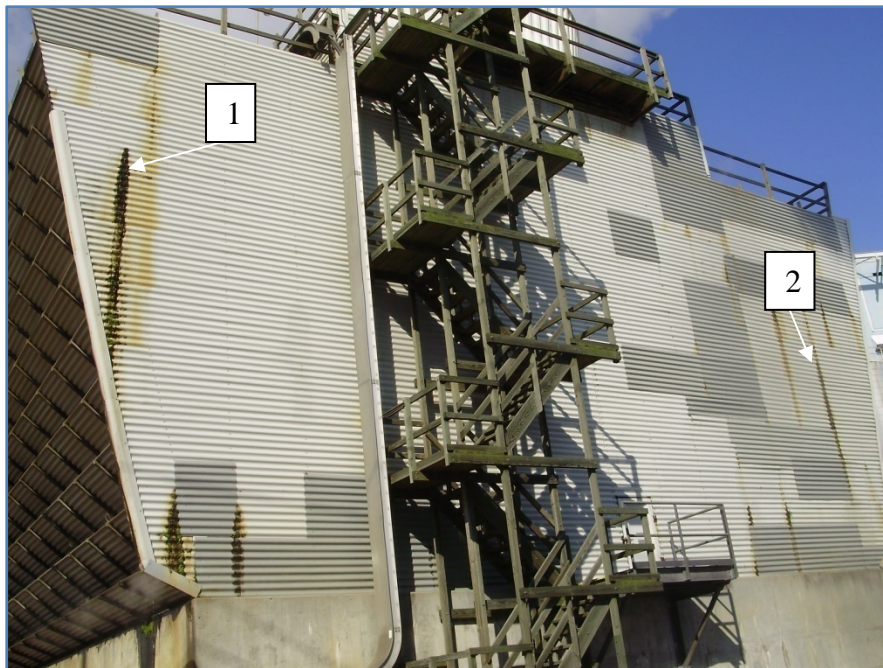
The casing material on the central plant cooling tower is composed of 4.2 inch corrugated fiberglass reinforced plastic. This material is a common product used in cooling towers and has replaced the compressed asbestos board that was originally installed on the tower. The tower was in operation at the time of inspection, which provided an opportunity to identify casing leaks. Many leaks have developed in areas that have ripped or split from normal wear and tear. It is recommended to replace the four end walls with a much heavier twelve ounce casing material which will be more resistant to tearing and splitting. Images of the end walls and damaged casing sections are located in figure three.

Figure 3: Exterior casing- Detail points one and two reference leaks on the end wall casing panels, many holes have been patched over the years but leaks have developed in many of the wetted section.

- 8.) Remove all four end walls and inspect perimeter columns thoroughly, replace end wall with new twelve ounce 4.2 corrugated FRP casing.

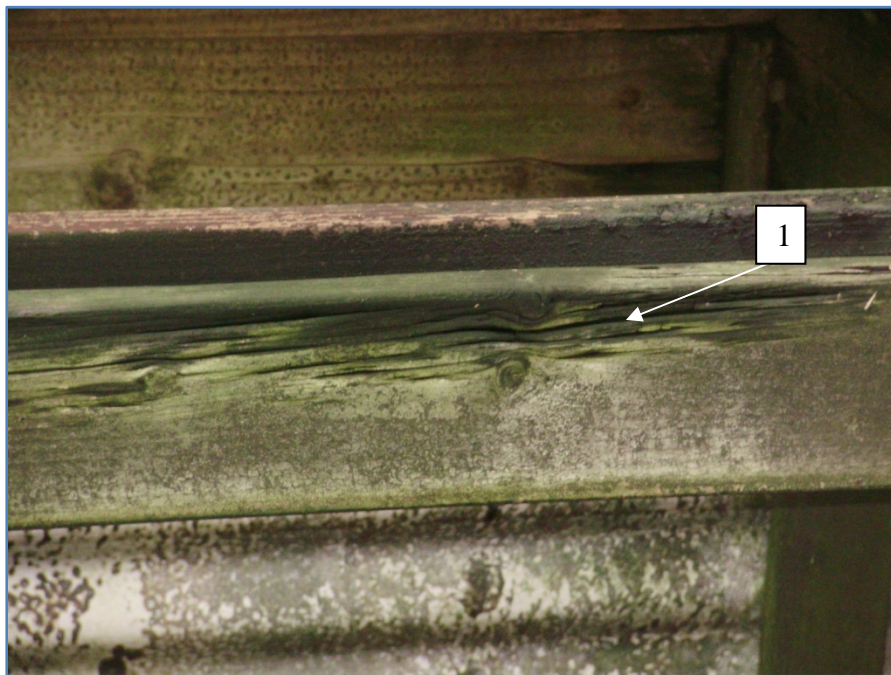
The Plywood fan deck is composed of 1-1/8" tongue and grooved four by eight treated material that is installed in the longitudinal direction of the cooling tower. The support structure for the decking is two by six joists orientated in the transverse direction of the tower. The structural condition of the fan deck joists was found to be average at inspection with a few rotted joists found at inspection. Numerous areas of the fan deck were found to be delaminating and deterioration was noticed on the surface. It is our recommendation to remove the existing plywood material and replace with either new plywood or pultruded fiberglass decking. Damaged 2"x6" fan deck joist should be replaced at this time. Images of the fan deck and support structure are located in figures four and five.

Figure 4: Top Deck- The underside of the cooling tower fan deck, inspection from the plenum area found a few joist members with fungal rot. Detail point one references rot striations in a 2" x 6" joist member in cell number four.

- 1.) Remove and Replace approximately (15) damaged double tie lines in cells three and four
- 2.) Remove existing fan deck and replace approximately (11) damaged fan deck joists on all four cells. Replace fan deck with either 1-1/8" tongue and groove plywood or SAFEDECK fiberglass decking.

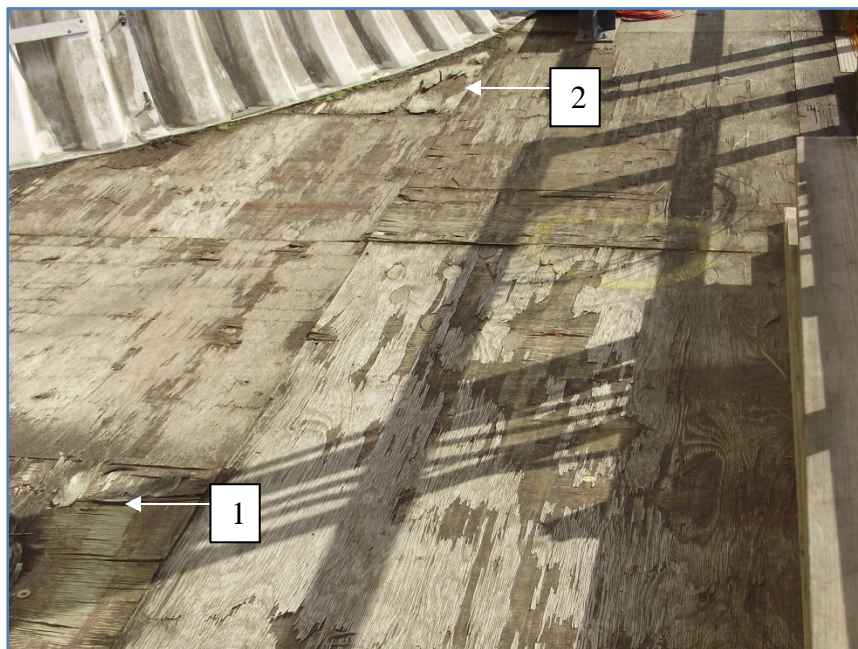
Figure 5: Top Deck- The top deck was found with a large amount of delaminating plywood material across the four cells.. Detail point one and two refer to a couple of areas that have started to peel back from the panels.

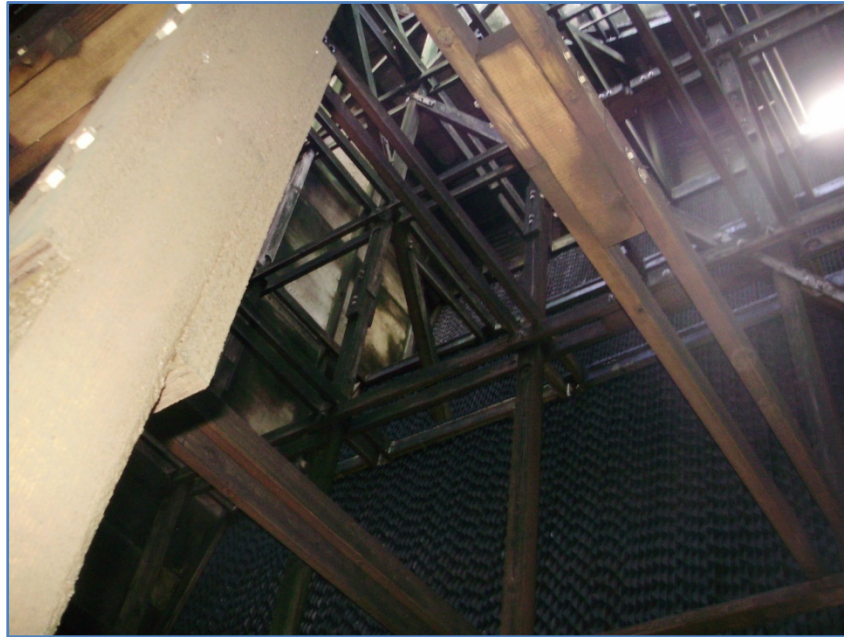
The columns consist of four by four pressure treated redwood. The columns are spaced on four foot longitudinal and eight foot centers in the transverse direction. The interior columns were visually inspected throughout the tower structure and verified with a sound test. The posts were found to be in good condition with no signs of delignification or internal fungal rot. An image of the structural posts is located in figure six.

Figure 5: Cell #2 columns-The columns were inspected in upper and lower sections of the plenum and were found to be in good condition.

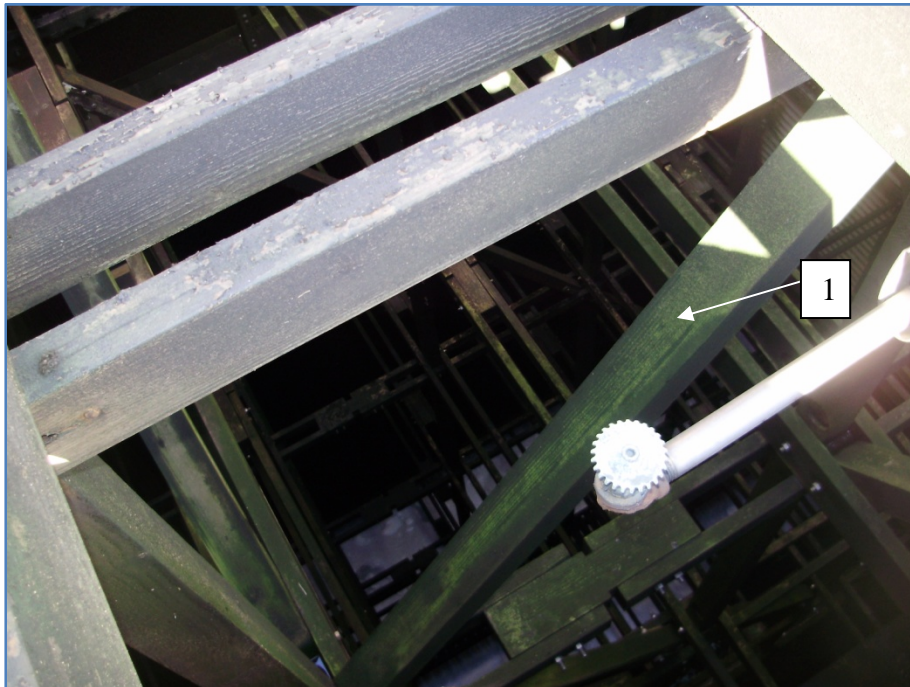
The bracing consists of four by four pressure treated redwood members orientated in both the transverse and longitudinal directions of the cooling tower. The purpose of the diagonal braces is to provide structural rigidity from loads in the horizontal direction such as wind loads. The majority of the braces were found to be in good condition with the exception of six braces that were identified in cell number four.

Figure 7: Internal diagonal brace: Detail point one refers to a brace that has started to show signs of surface rot

- 3.) Remove and replace (7) 2" x 12" curb boards on cells three and four.
- 4.) Remove and replace (12) damaged diagonal braces in cells three and four

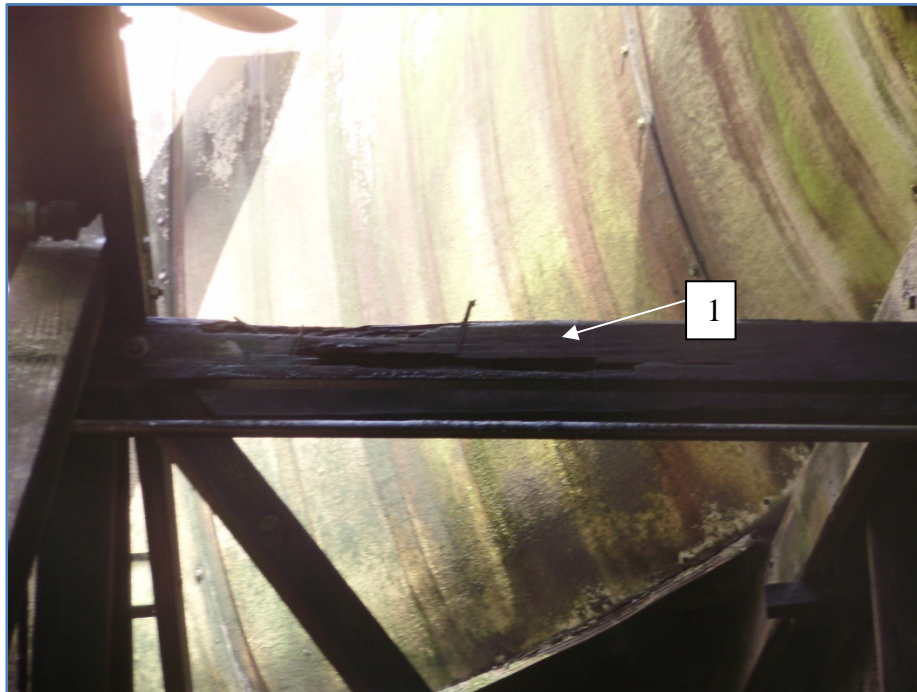
The structural tie lines consist of two by four inch treated redwood lumber. The tie lines are orientated in both the transverse and longitudinal directions of the tower and placed at each vertical level on six foot centers. Approximately (10) double tie lines were found to be affected by internal fungus in cells three and four. Cells one and two showed no significant signs of damage within the tie line members and all of the associated hardware was secure. It is recommended to replace the damaged tie lines in cells three and four at the next available opportunity.

Figure 8: Structural Tie Line- Detail point one refers to a two by four tie line member that has deteriorated from biological rot.

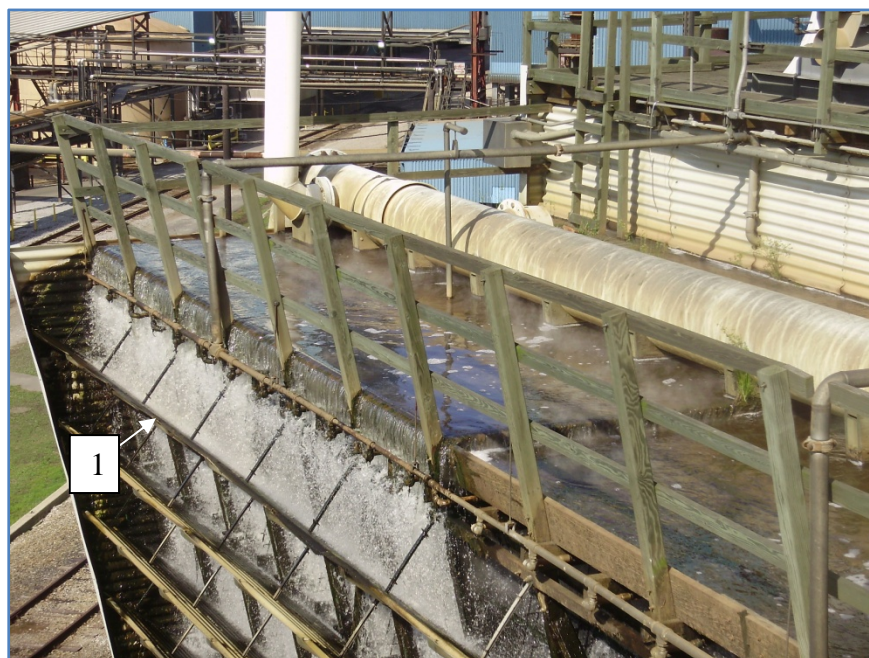
The distribution system consists of a plywood deck that is supported by two by six support joists connected to the structural redwood posts. The decking has nozzle orifices bored on one foot centers and utilizes Marley's standard spiral target cross flow nozzles. Each cell has two Marley flow control valves that feed into a distribution box, evenly distributing the water to maintain a head pressure on the nozzles. Defective valves were found on the south sides of cell numbers one and four. These damaged valves allow water to overflow the basin walls blocking air flow at the louver face and permit condensed water to enter the plenum area. Approximately (7) two by twelve basin curb walls were found to be extremely decayed on cells three and four. The distribution decking material and support joists were inspected from both the outer face of the tower and inside the plenum. All of the basin decking was found in favorable condition with no split or broken joists identified. Recommendation is to replace the damaged curb boards and broken valves at the next available opportunity. An image of the distribution deck is located in figure nine.

Figure 8: Distribution Deck – two broken flow control valves were found on the tower distribution system. Detail point one refers to the outer curb wall that is engulfed in water. This mass of water restricts airflow through the cooling tower and hinders efficiency.

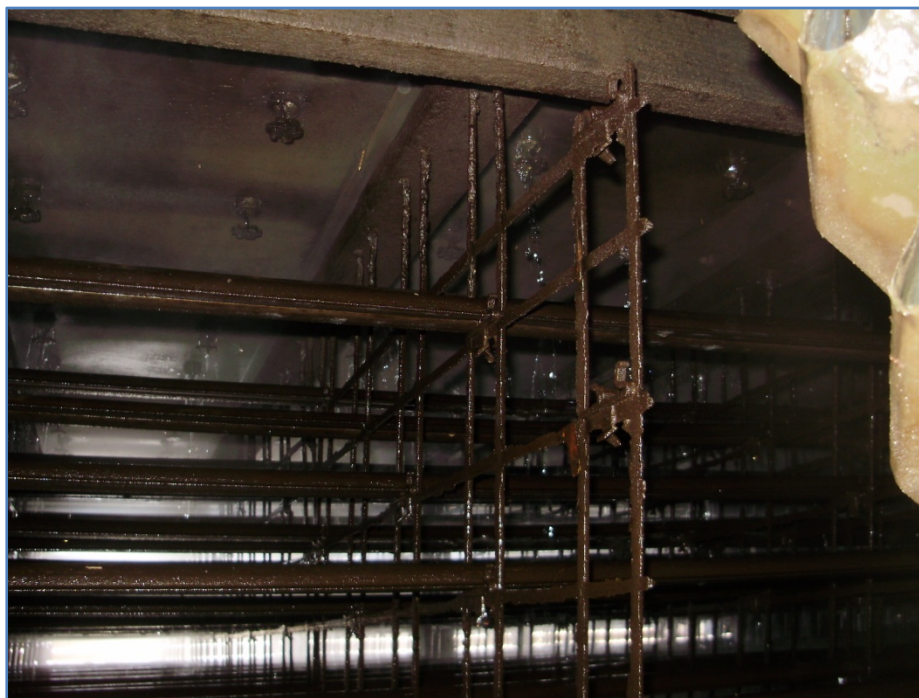
Figure 10: Splash fill material- The fill material was found to be in relatively good condition with no collapsed or significantly damaged sections found at inspection.

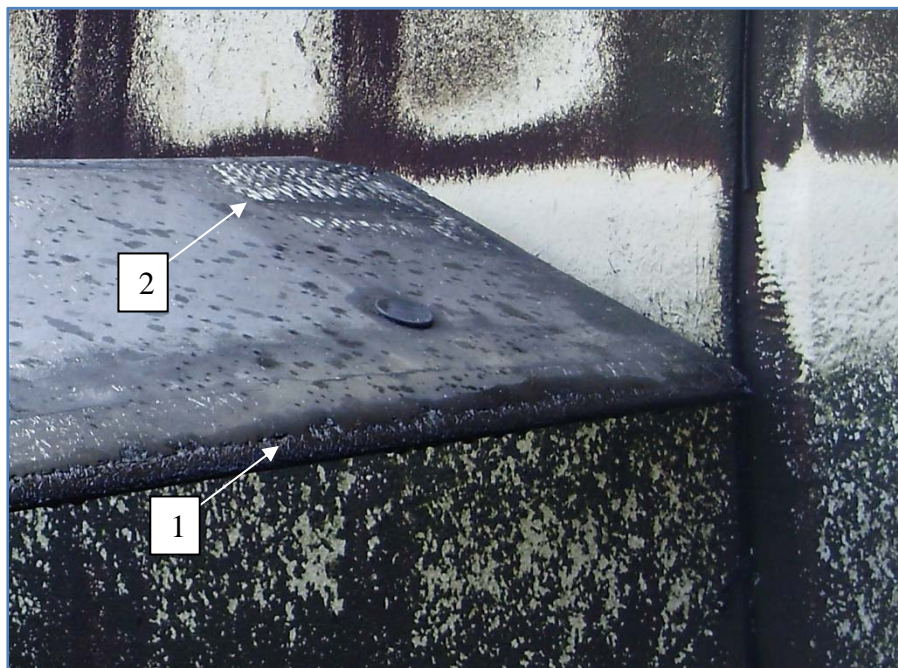
The existing fans are Marley twenty four foot diameter, eight bladed fiberglass fans. The tip clearance was checked on all four fan assemblies and found to be satisfactory. The fans have been in operation for over fourteen years and have started to display a significant amount of wear. The fiberglass UV coating has deteriorated on all four fan assemblies and the fiberglass bonding fabric is exposed on numerous areas of all the fan blades. The pitch angles were measured on all of the fan blades and were found to be inconsistent but not detrimental to operation. The leading edge on all of the fans was found to be significantly deteriorated, this is the result of water entering the plenum section from either failed drift eliminators or overflow from the broken valves. The most compelling observation made was the noticeable sway in the tower structure at the frequency of the fan speed. This horizontal motion is attributed to the fan assemblies being out of balance due to wear and tear. Based on the current condition of the fan blade assemblies and the noticeable unbalanced operation it is our recommendation to replace all four fans with new Hudson aftermarket Tufflite III fan assemblies. Images of the fan assemblies are located in figure eleven.

Figure 11: Fan Blade- The fan blades were found with a considerable amount of wear and pitting in the fiberglass. Detail point one refers to pitting on the leading edge of the fan blade that is caused by water droplets invading the plenum. Detail point two references a section of the fan blade wear the UV barrier has worn away and the fiberglass mesh is visible

- 5.) Replace all four fan assemblies with new adjustable pitch fan assemblies. All fans should be properly sized with consideration placed on input motor horsepower and current gearbox ratio. Fan pitch should be set to draw maximum amperage from drive motors.
